My Safe Home Inspection

5345 Burgess Ave
Cocoa, Florida 32927

Legacy Roof Report Summary

Roof Condition Certification Form

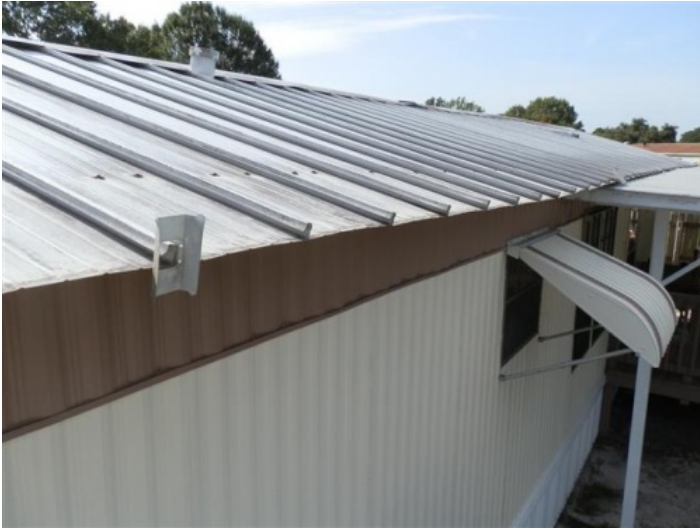
- No
- Yes, explain: The rear roof slope is bent at the end of the overhang but does not affect the roof to wall connection. The metal fascia has been removed.

Metal Fascia Has Been Removed

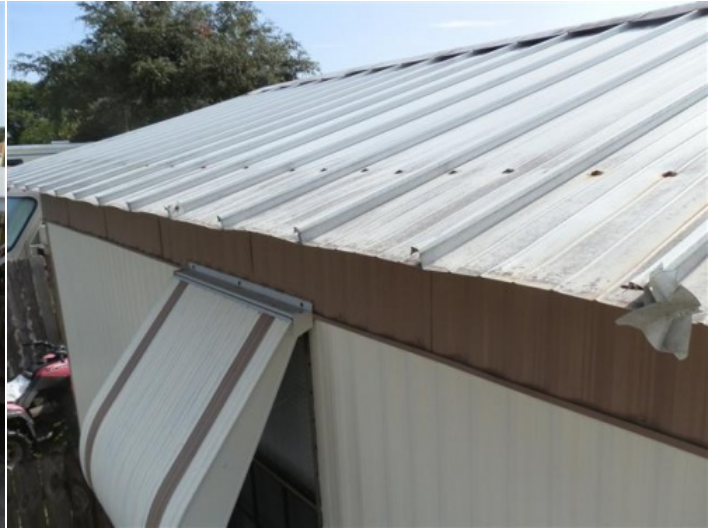
Metal Fascia Has Been Removed

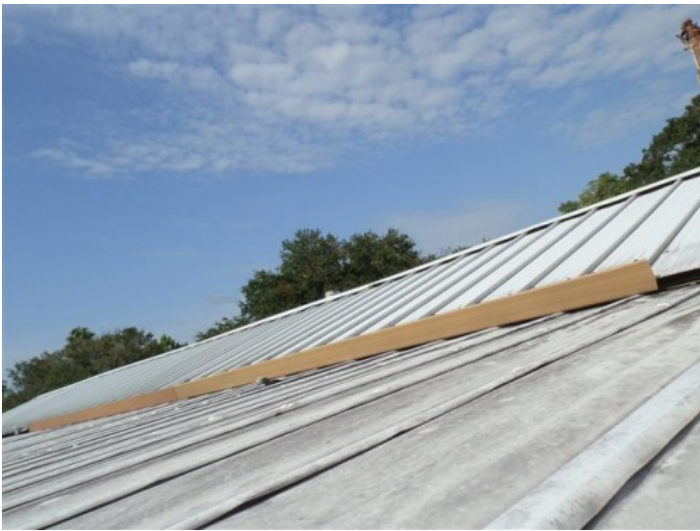
Roof Material: Metal, Rear Slope

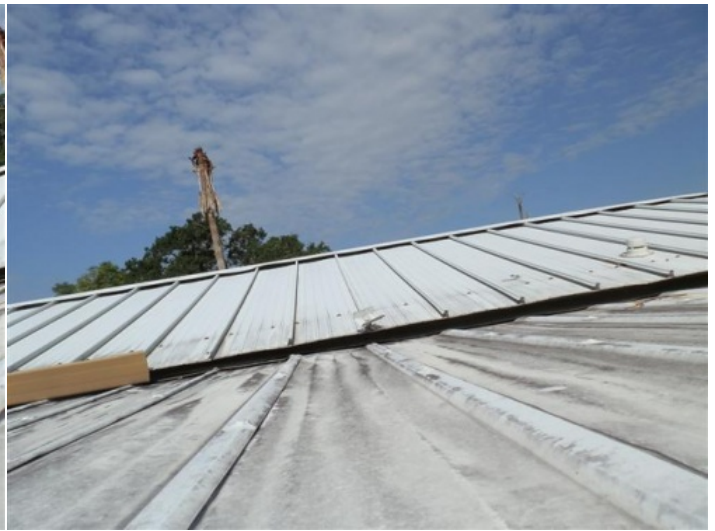
Roof Material: Metal, Rear Slope

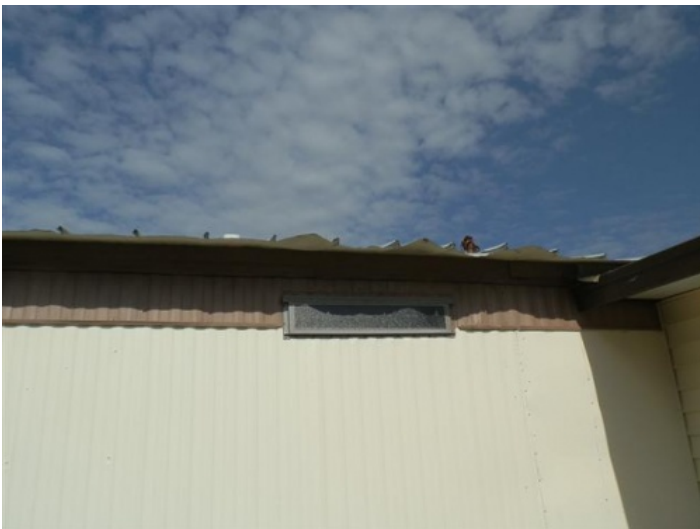
Roof Damage Observed
