My Safe Home Inspection

5345 Burgess Ave
Cocoa, Florida 32927

Legacy Roof Report Summary

Roof Condition Certification Form

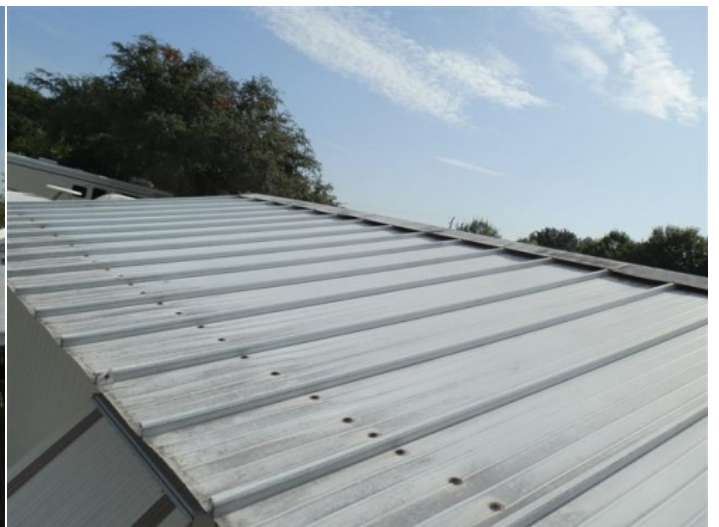
Roof Material: Metal, Front Slope
