My Safe Home Inspection

Legacy Four Point Report Summary

ADDRESS INSPECTED: 2010 Adams Ave , Melbourne, Florida, 32935

DATE INSPECTED: Sep 11, 2013, 10:00:00 AM

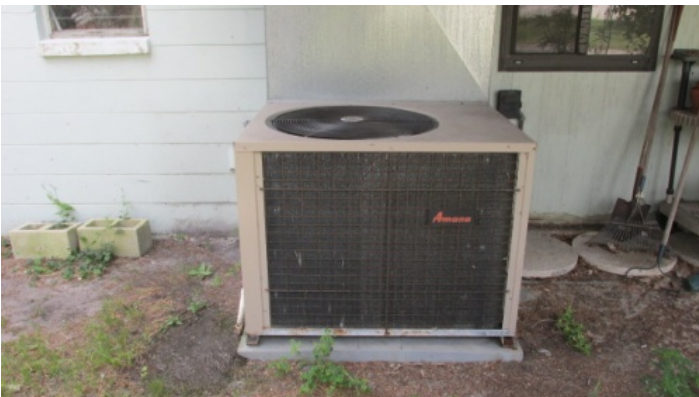
Package heating and cooling unit

Heating & AC package unit

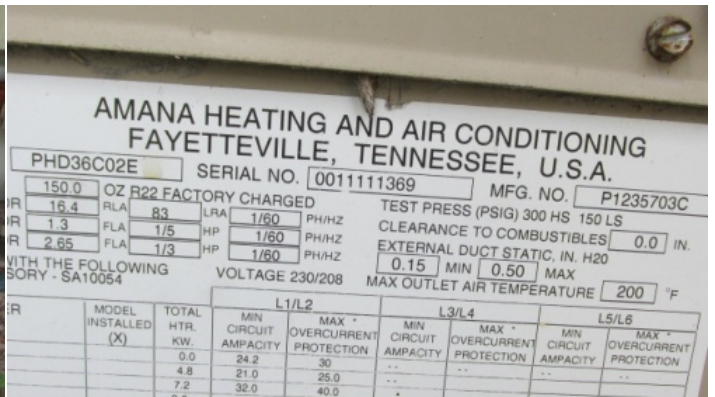
Heating & AC package unit label - mfg 2000

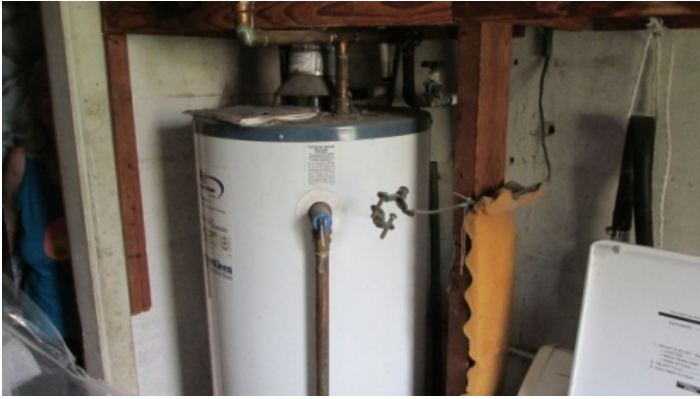
Gas water heater

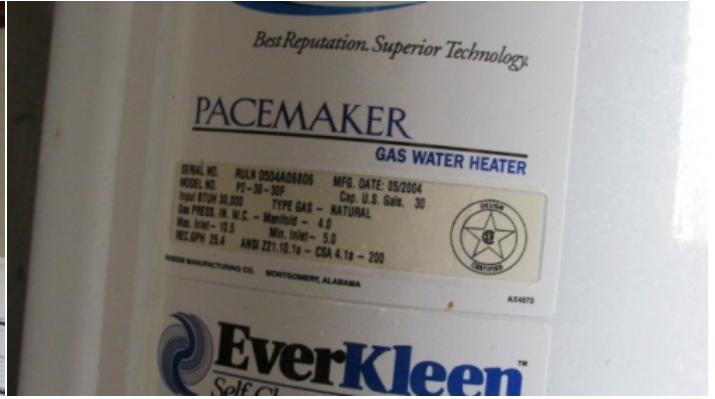
Water Heater label - mfg 2004

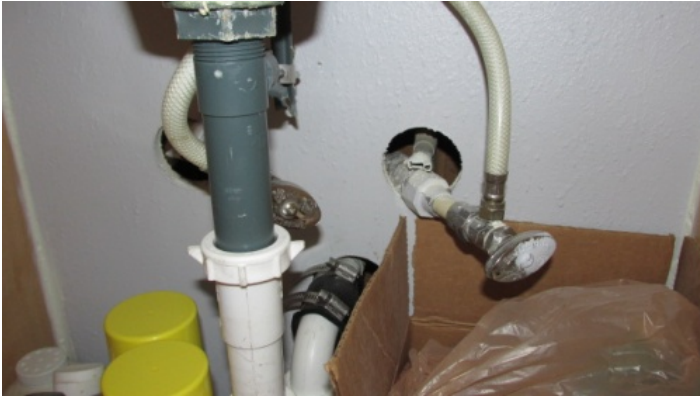
Bath Plumbing (under sink) - shut off valves, flex vinyl water supply lines

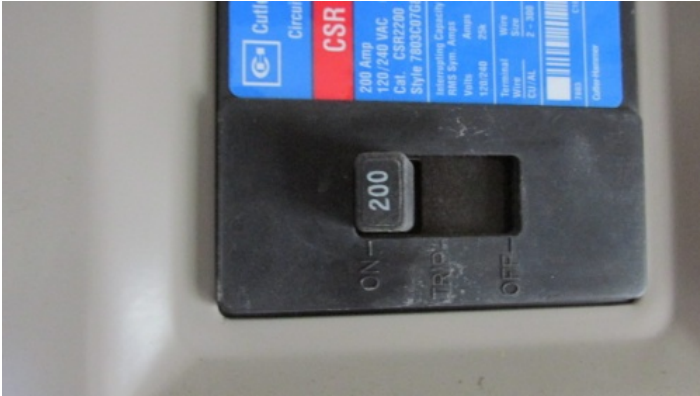
Main Breaker - 200a
